Installation of Cold Case Aluminum Performance Radiator in 2005 GTO

Performed October 2015

By: Chris Gray

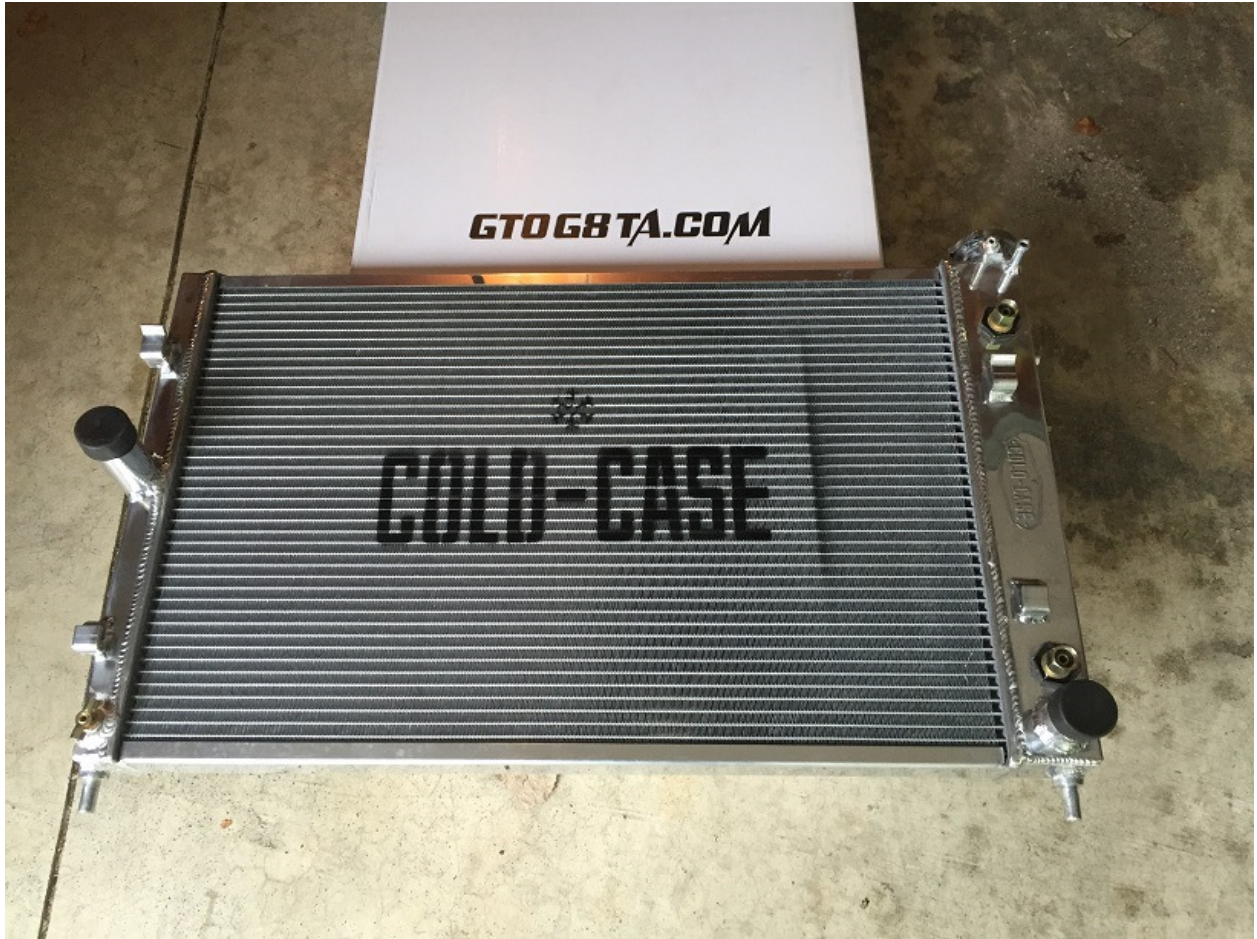
Here is the new radiator in all its shining glory:

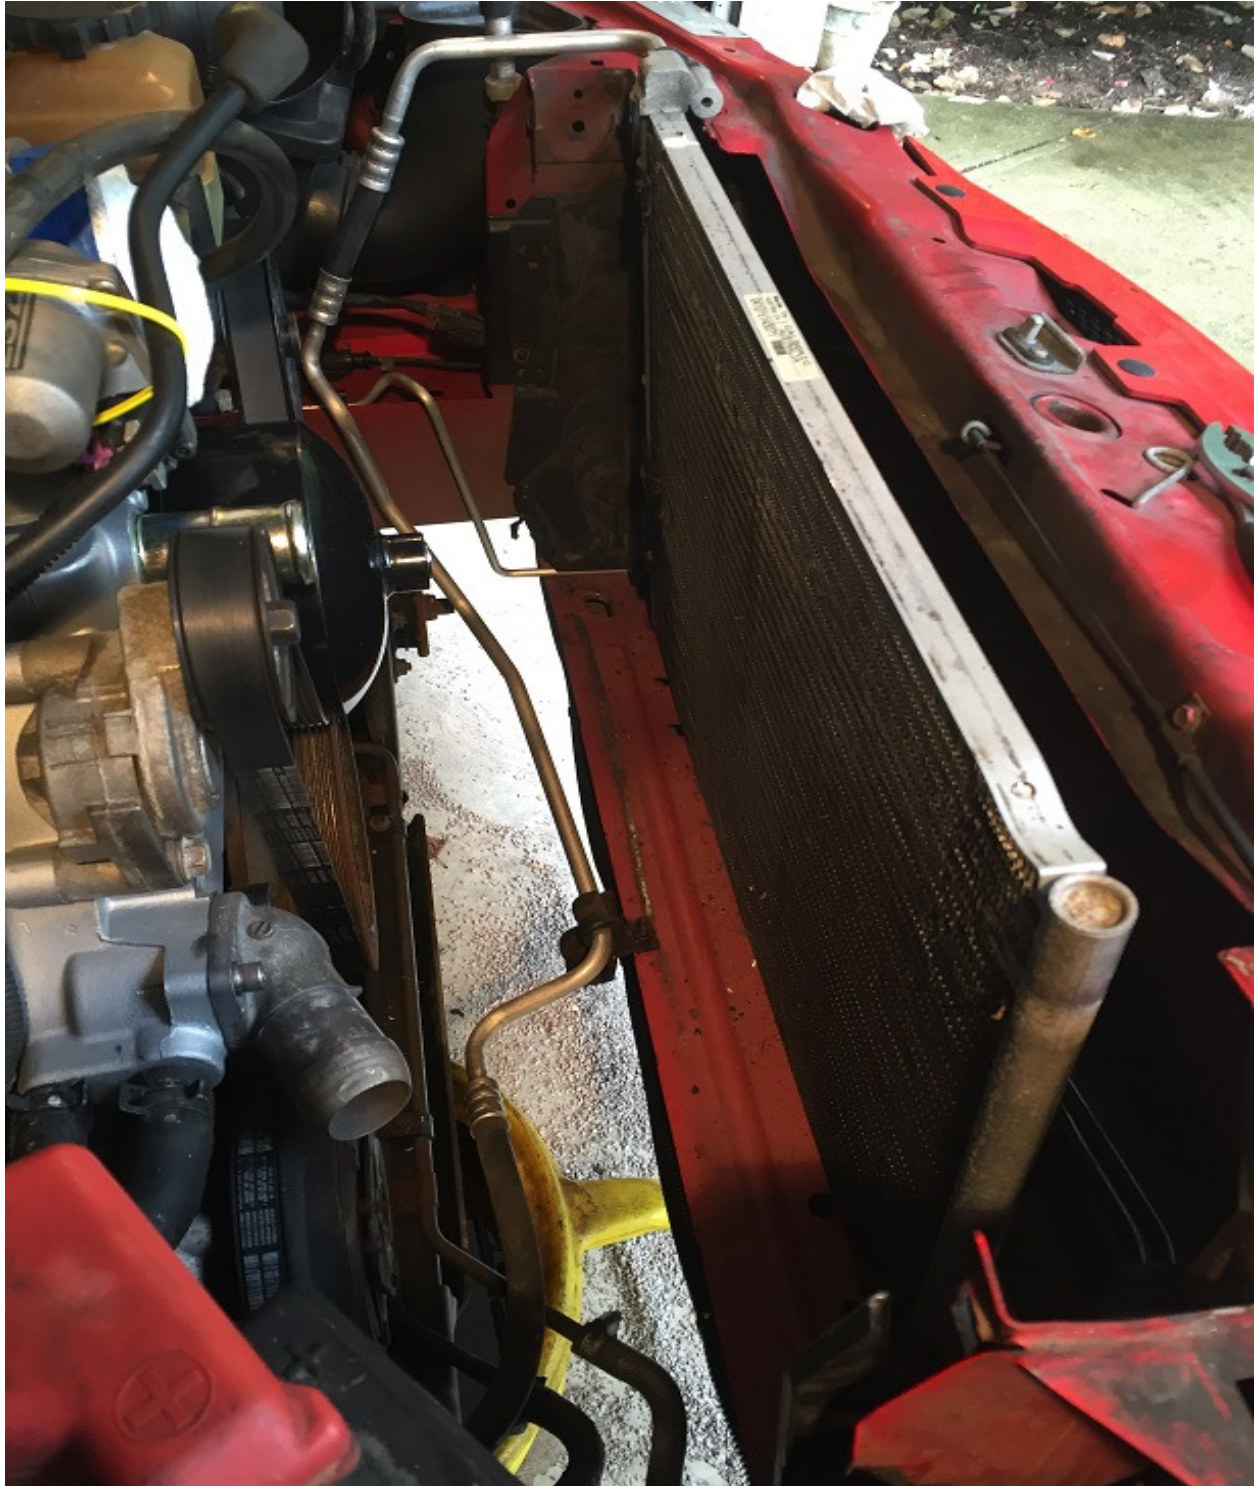
Here is the radiator bay ready to get its new super cooler:

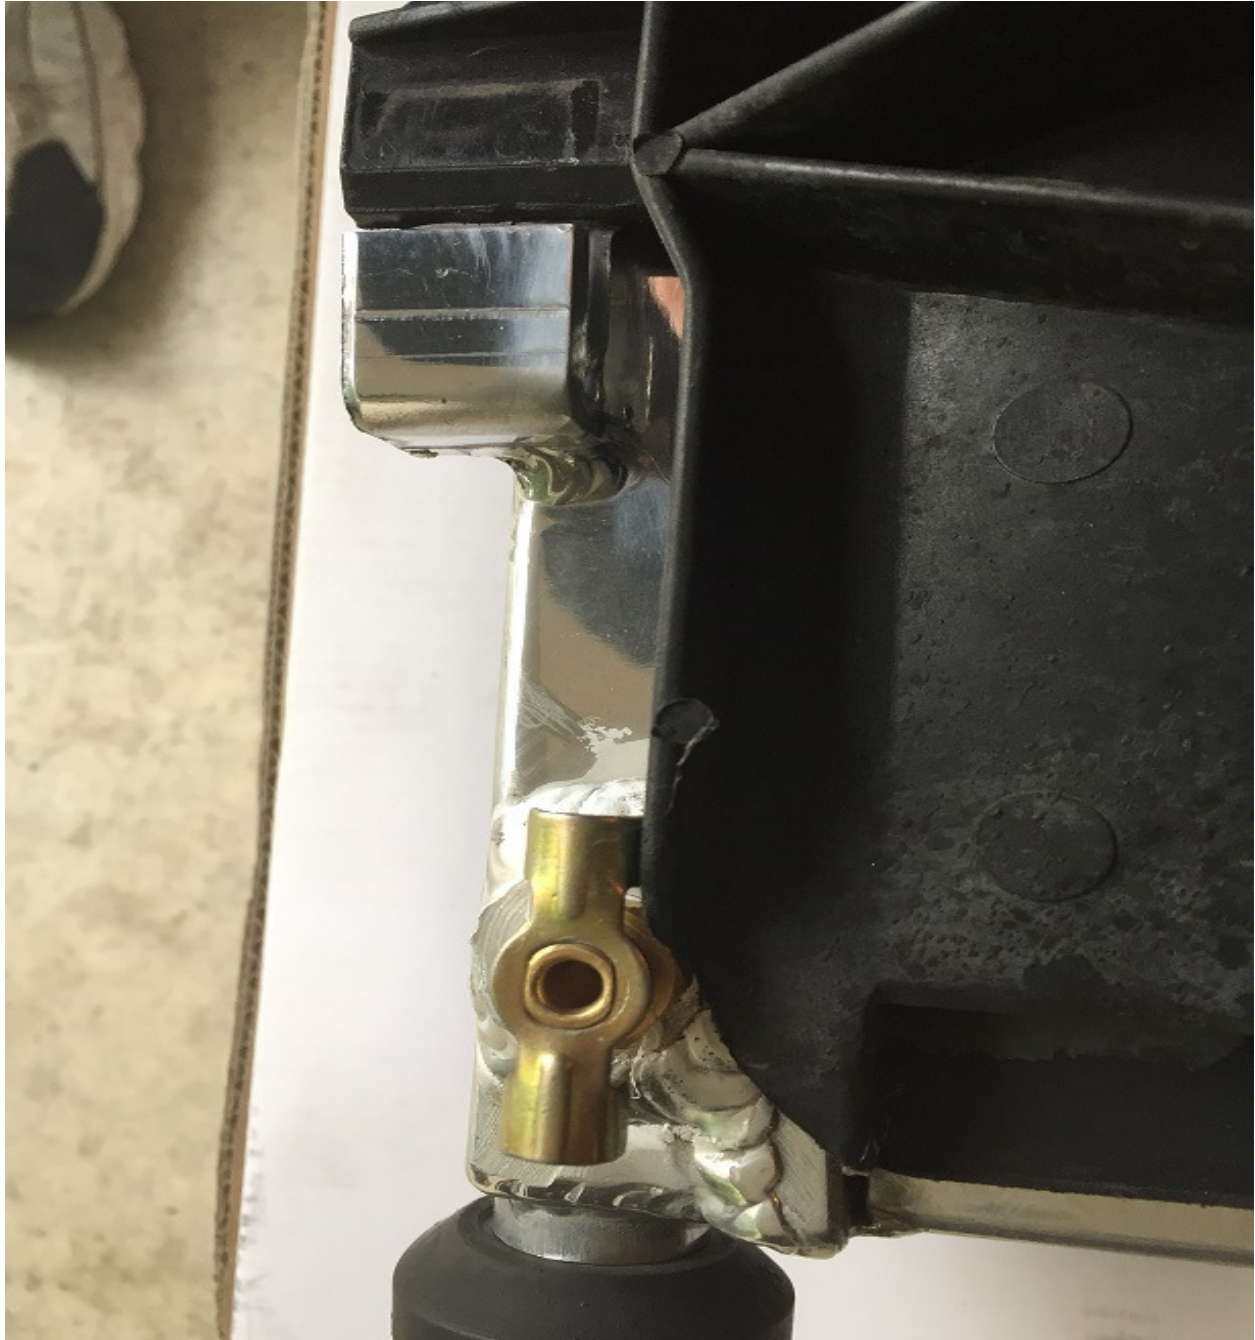
Test fit of the fan assembly before installation in the car – shroud is contacting the drain petcock preventing the assembly from dropping down enough for the tabs to engage the radiator retaining clips:

Simple solution – trim the shroud (marked in white). This is not a critical stress area so this should not create any issues:

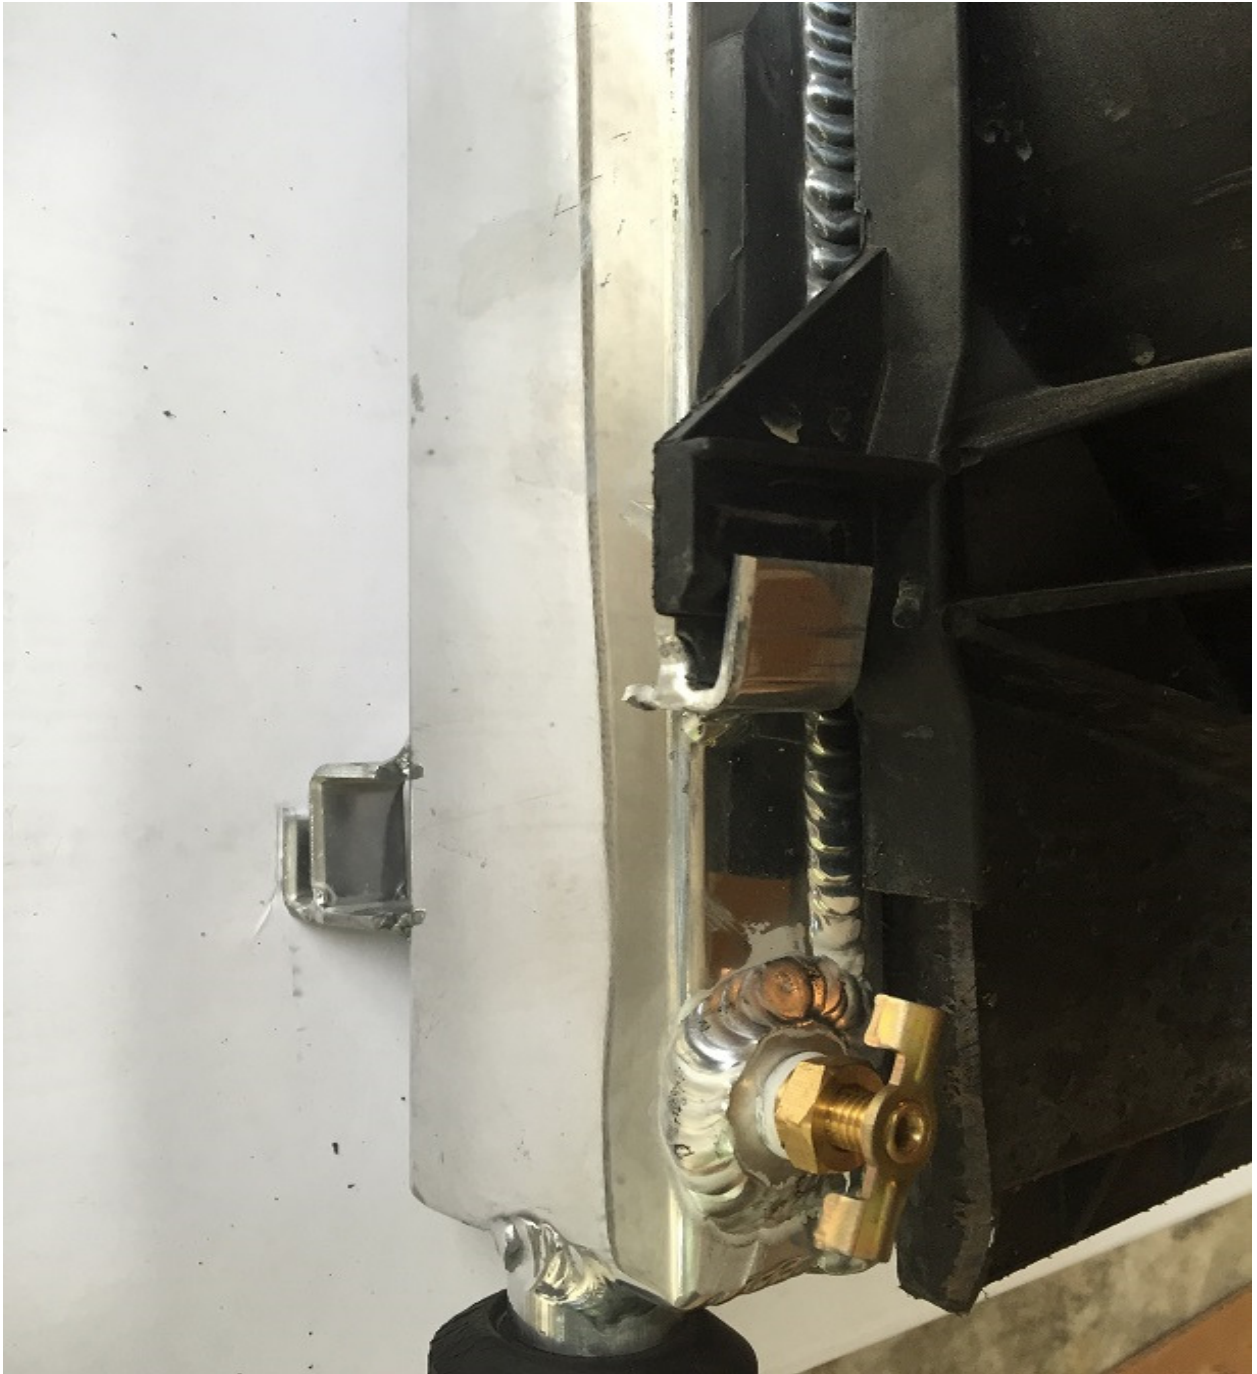
Here is the fit after completing the shroud modification:

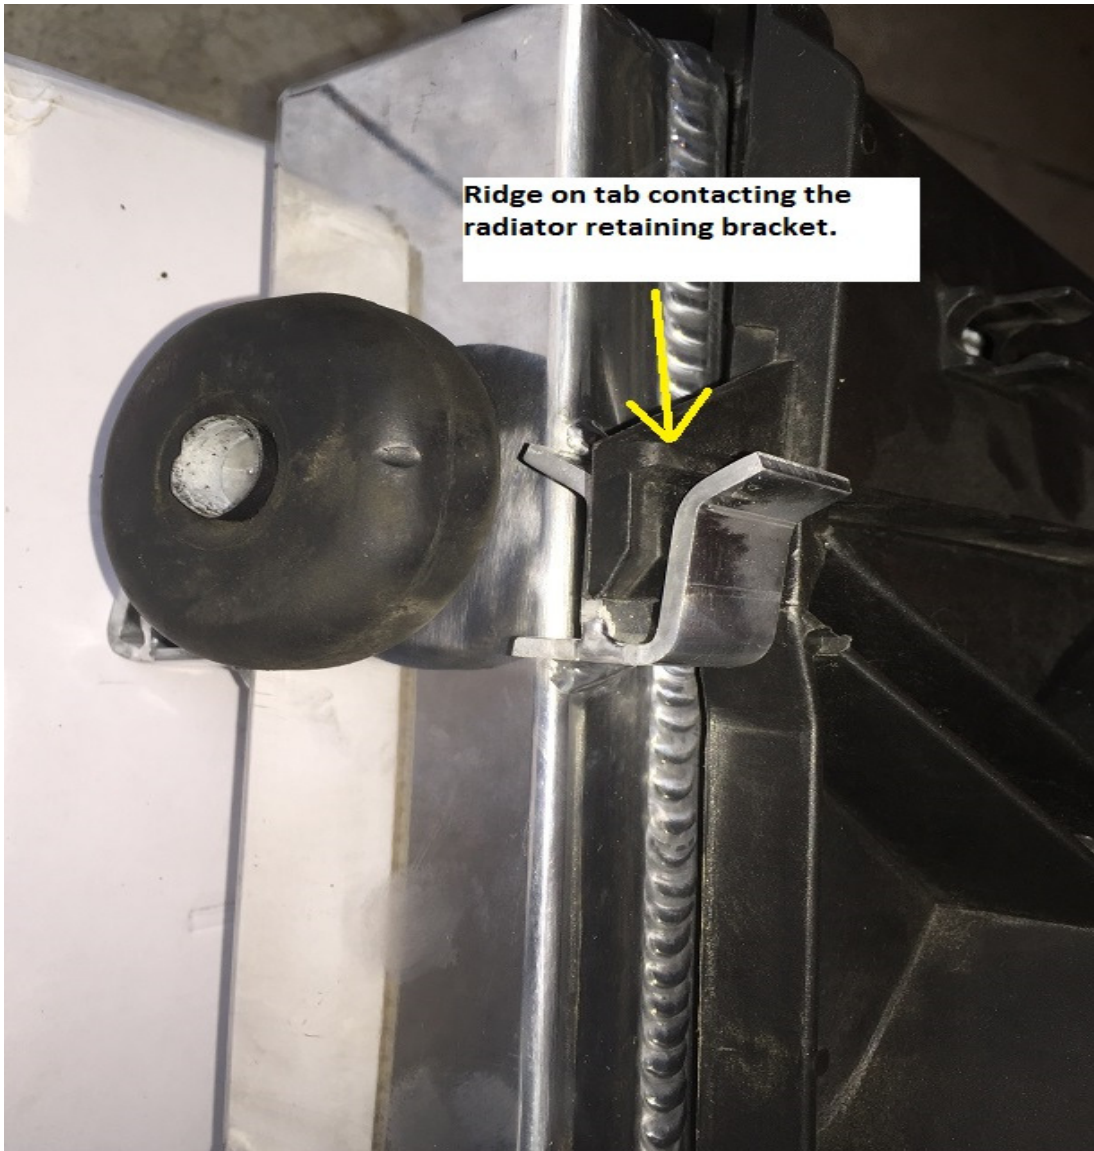
As you may have noticed from the previous picture, the tab does not slide all the way into the retaining bracket. This due to the location of the bracket. The top bracket stops the tab from fully engaging once the ridge on the tab contacts the bracket:

The factory radiator had brackets that allowed the tab to completely seat and then also locked it in by latching on to the ridge on the tab. I realize this type of bracket is not as easily duplicated in aluminum (factory is plastic), however after installation I can say that the fan assembly is sufficiently secured.

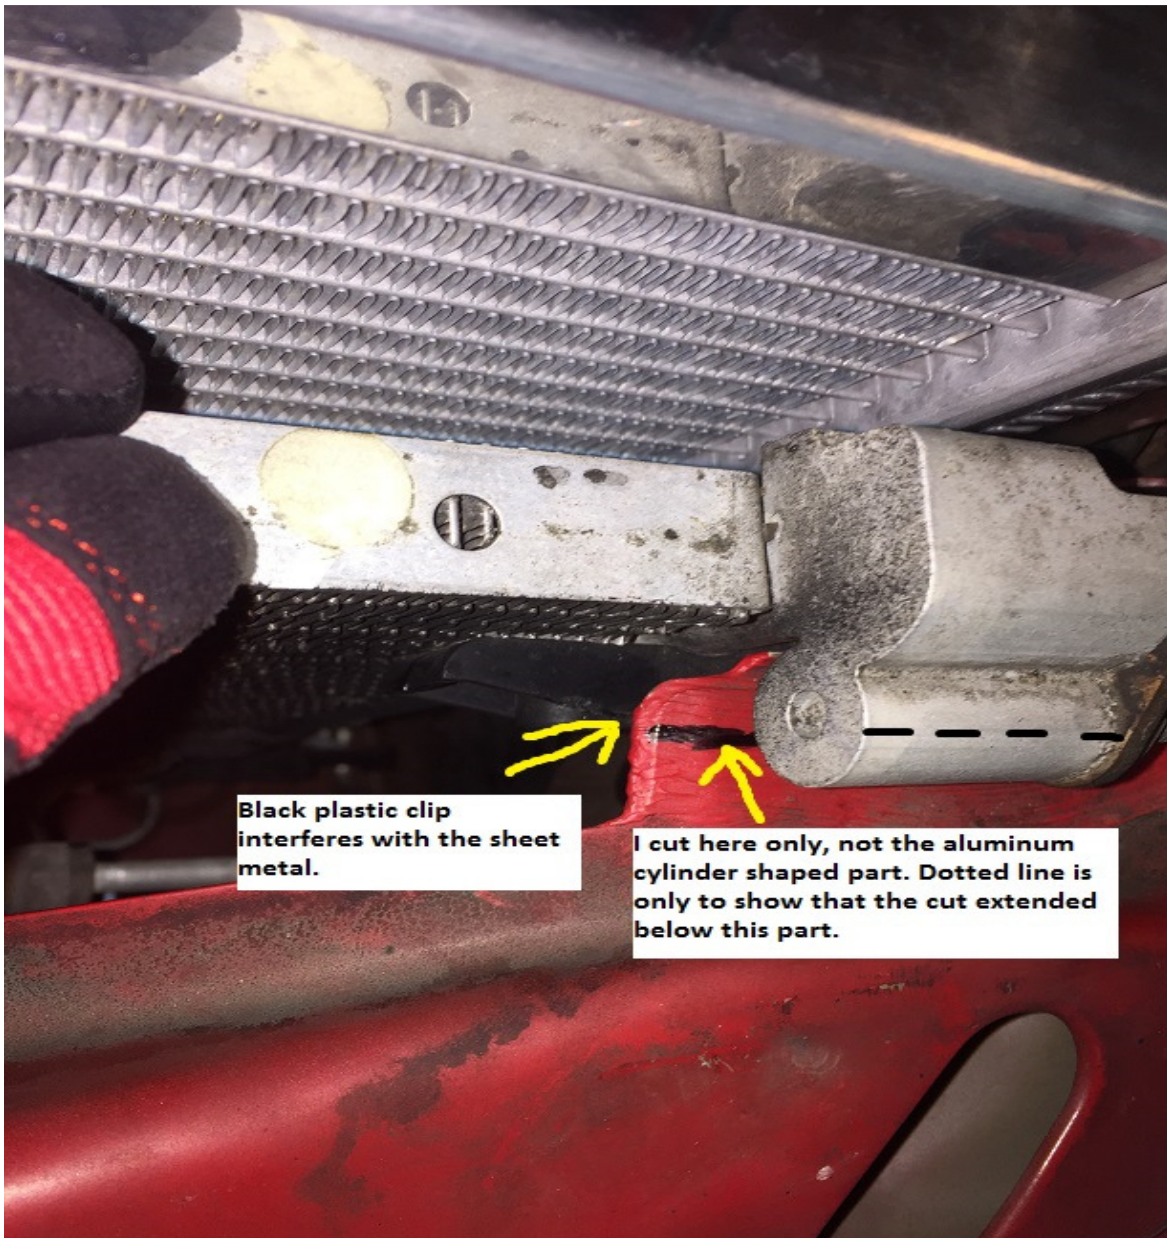
The next “issue” was more related to the car than the radiator. The larger radiator exaggerated what was already an issue, but could be worked around with the factory radiator. The AC condenser mounting tab/clip on the upper driver side contacted body sheet metal when raised, which prevented the condenser from being able to lift up high enough to lock in the tab to the radiator retaining bracket. Despite trying (for way too long) to work around this by taking the screw out of the clip so it could flex, manipulating the radiator and condenser in multiple positions, - I decided the only fix was to remove some of the sheet metal:

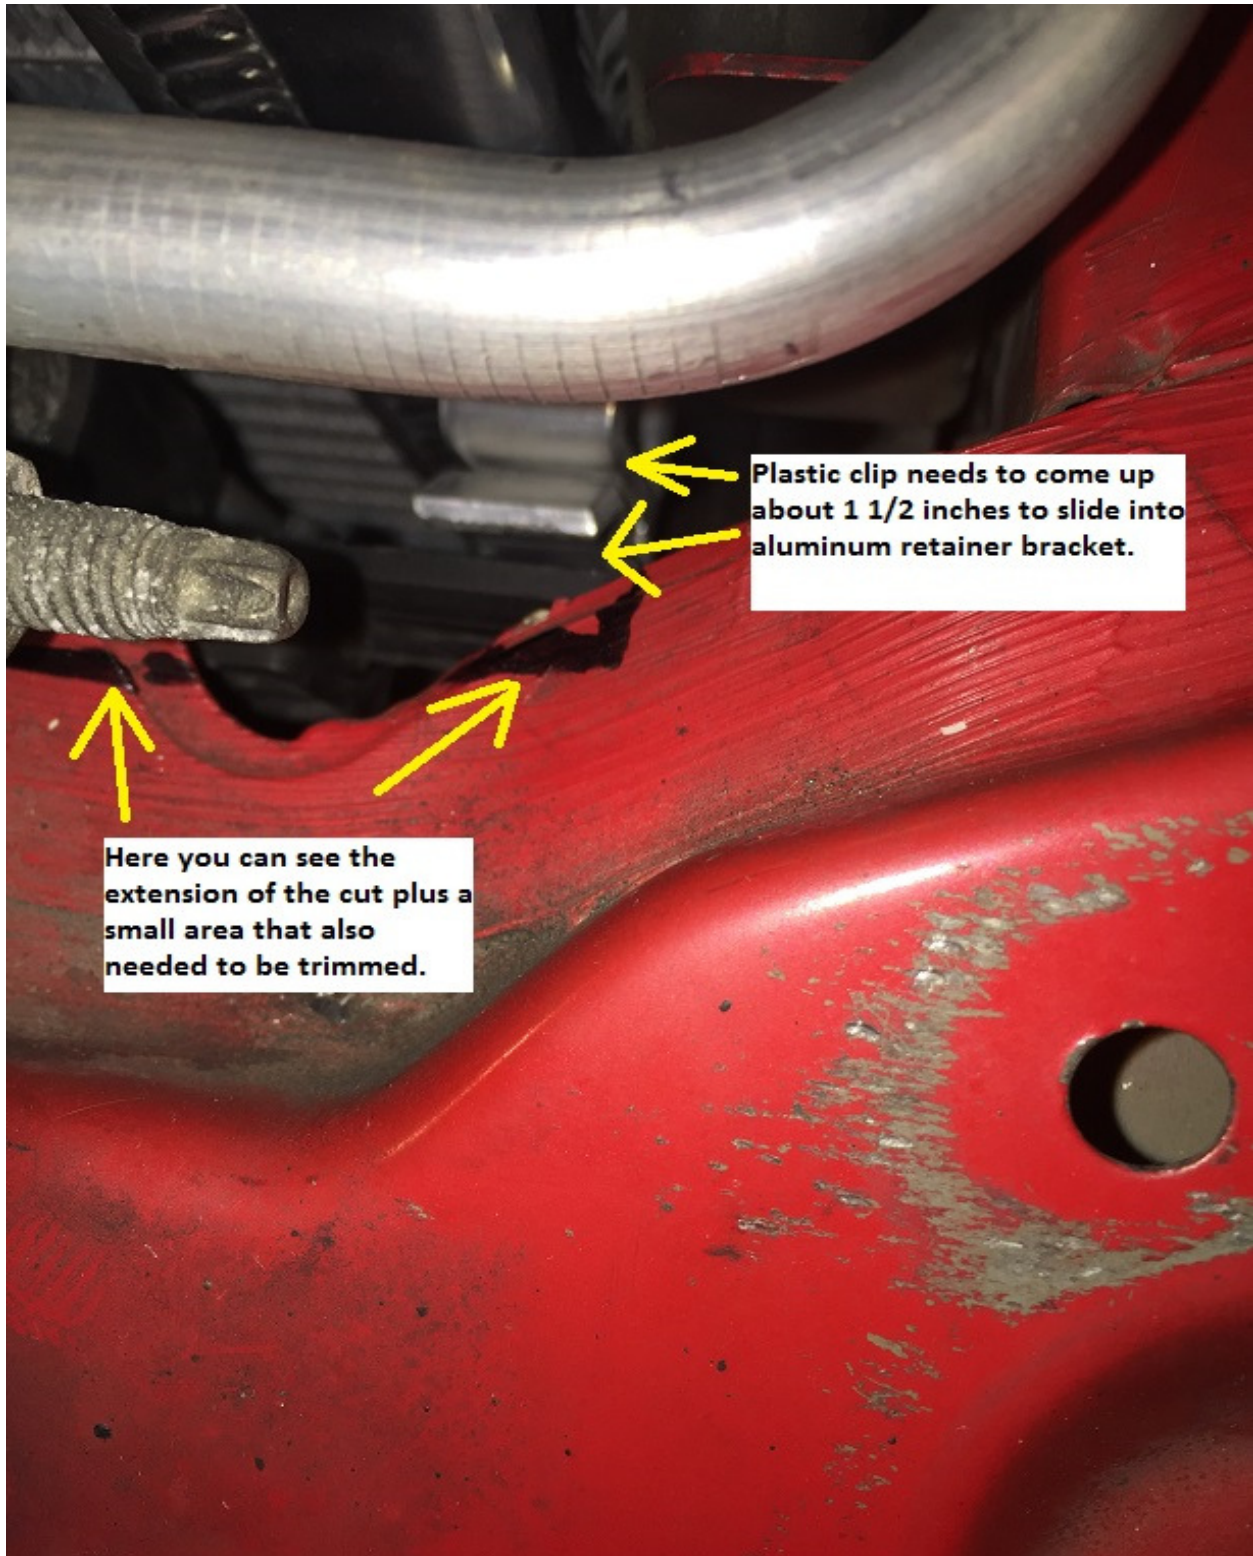
Another photo of the interference issue:

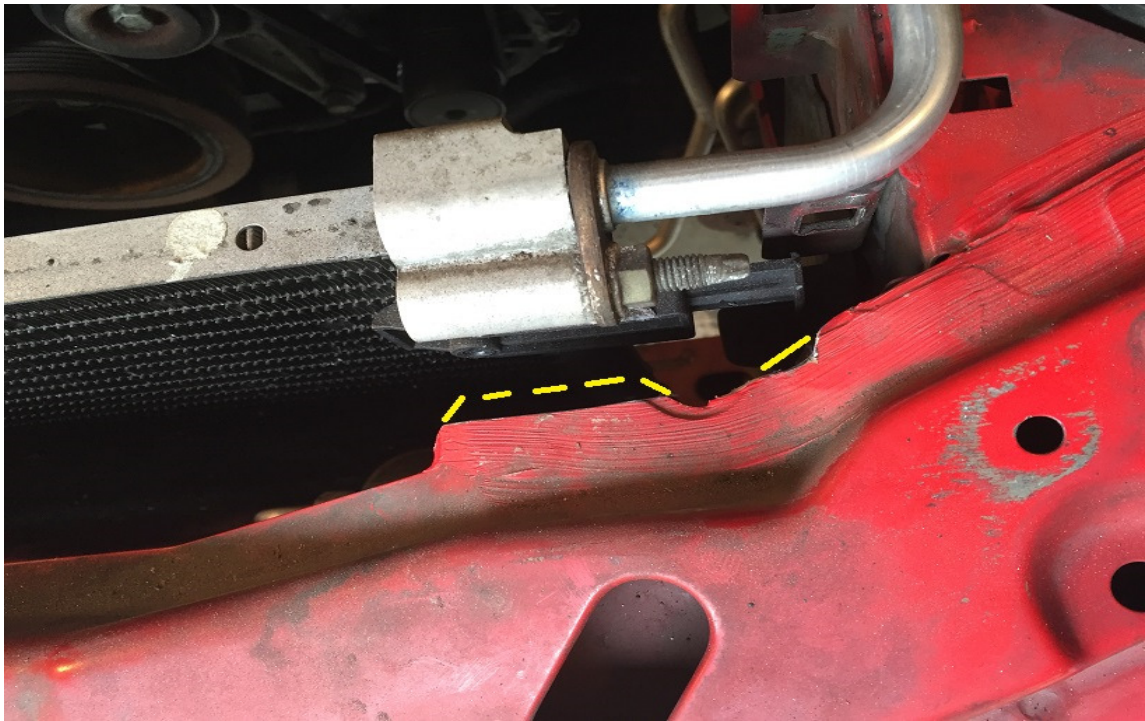
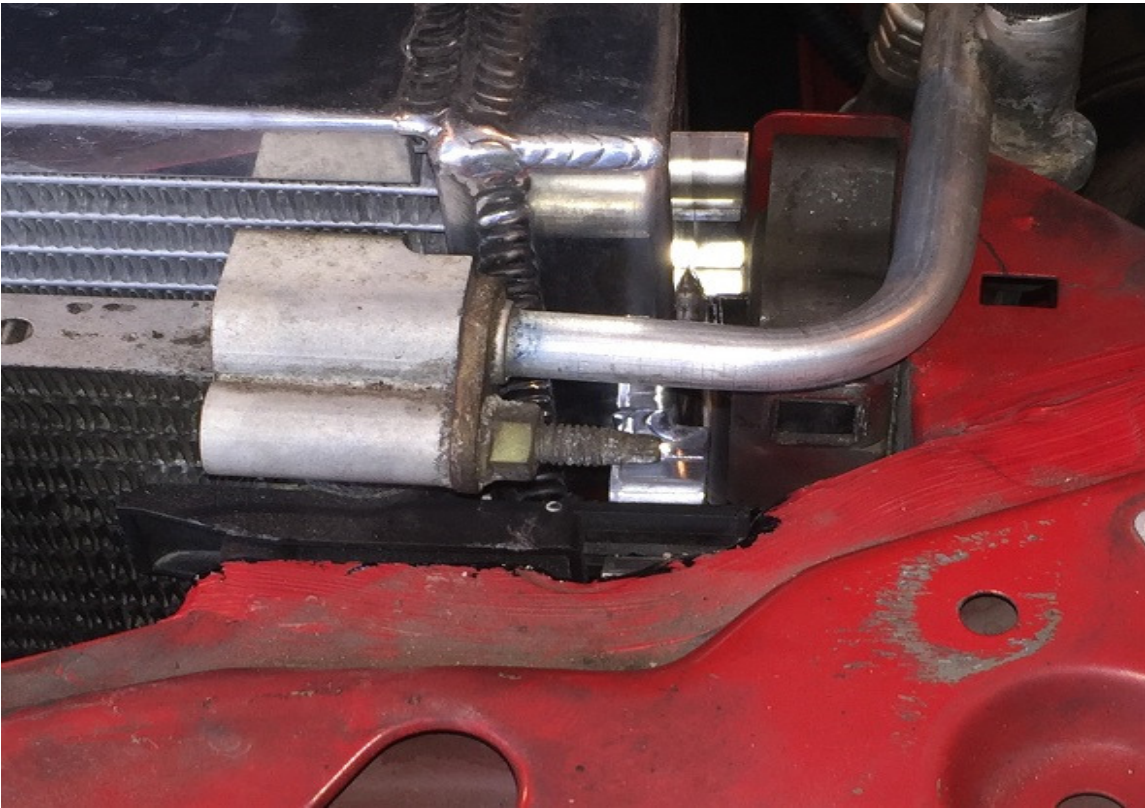
Once the sheet metal was removed, piece of cake:

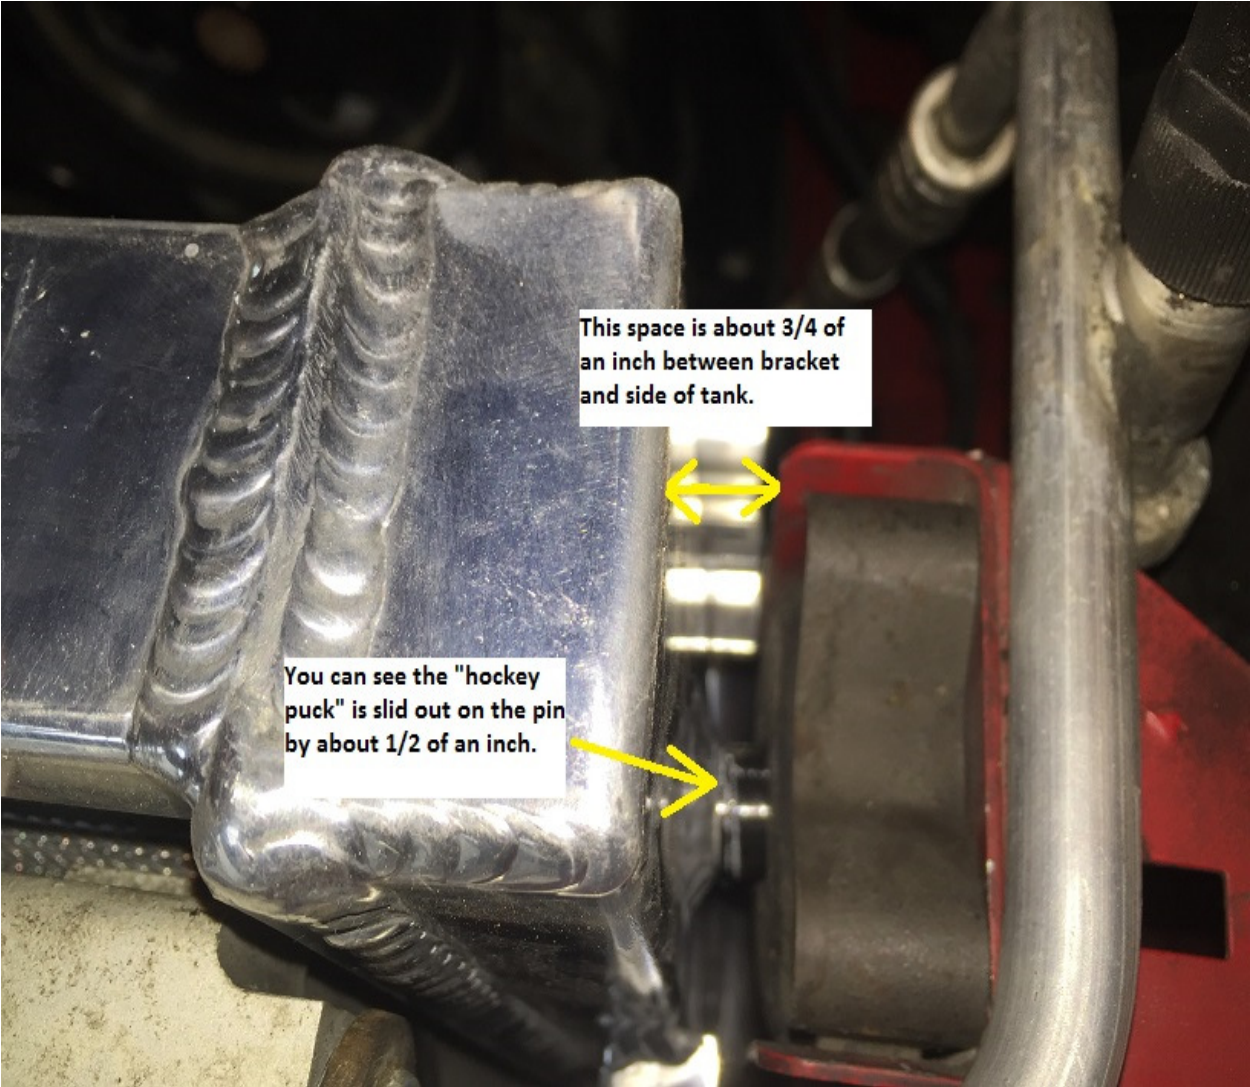
Now I checked the fit and found that the radiator seemed to be biased toward the passenger side. There was a gap on the driver side between the side tank and the "hockey puck" bushing retaining bracket:

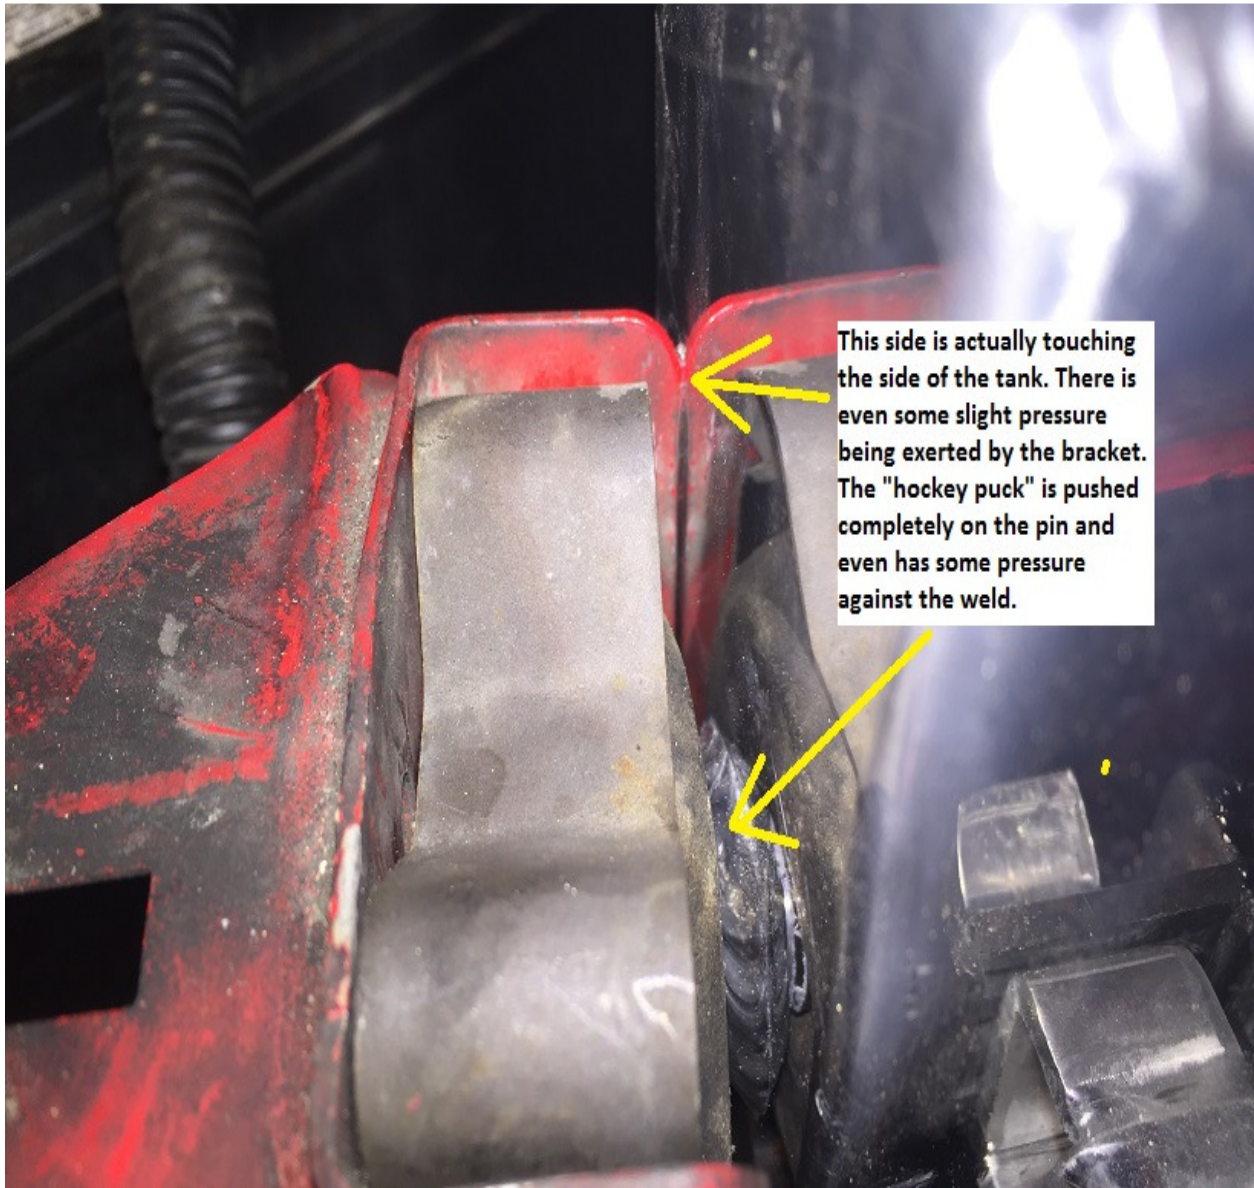
There was not only no gap, but it was actually pushed up against the “hockey puck” bushing retainer steel bracket:

Solution – remove more sheet metal. I ground down about 3/16 of an inch from the bracket where it was touching the tank. This still left plenty of material for the bracket to maintain its integrity required to retain the “hockey puck” and spring clip. I now had about 1/16-1/8 of clearance between the bracket and the tank (I coated the ground edge with some black chassis paint):

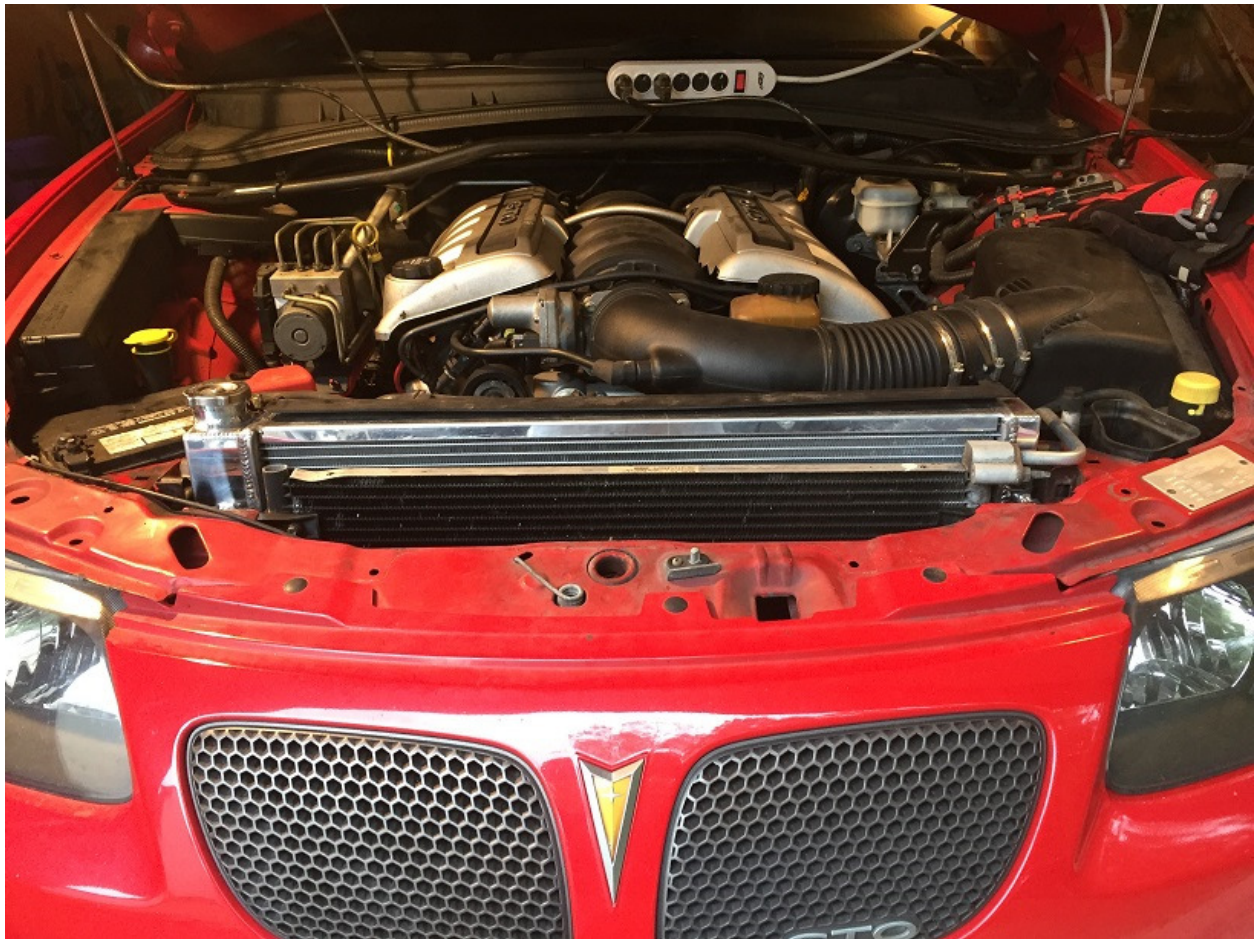
Anyway, this seems to have eliminated the hurdles to get the radiator fully installed with all accessories, hoses, clips etc. back in place. Final fit of the radiator, location of hose connections and mounting tabs all seem to be perfectly fine for safe and secure operation. With the exception of the couple of mods I had to do the car, this was a fairly straightforward install and overall I am very happy with the way it fits. And it even looks awesome!

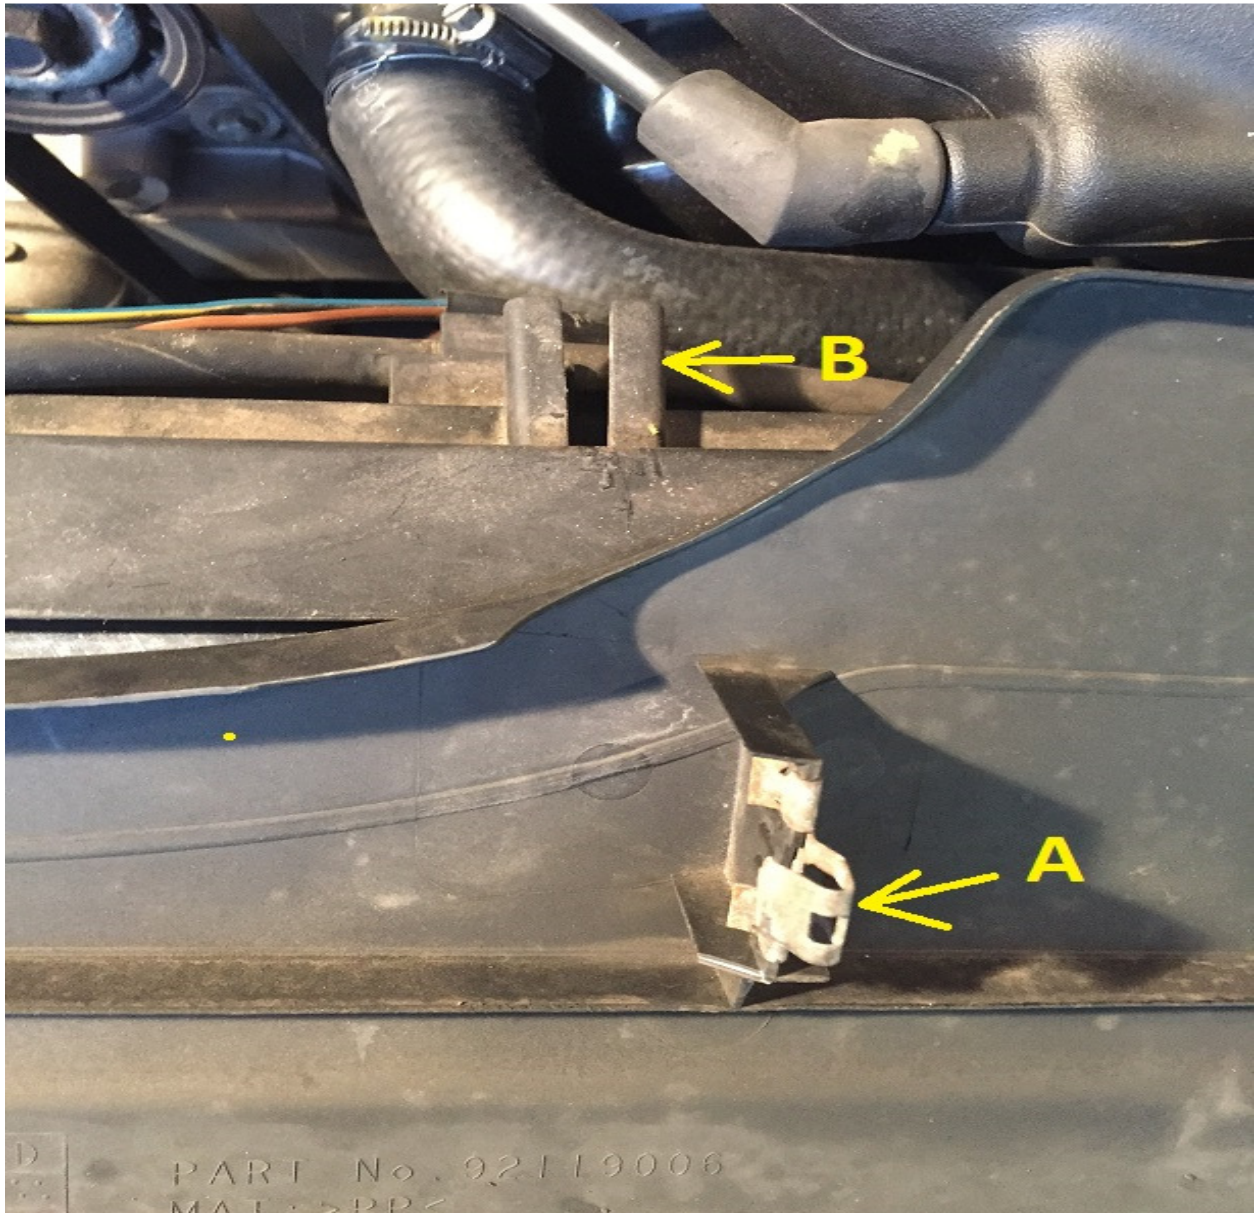
There is a mounting tab and clip (A) that are attached to the underside of the cover and engage with a slot in the fan shroud (B):

Since the fan shroud is now closer to the engine the clip attachment point is causing the top cover to be out of alignment.

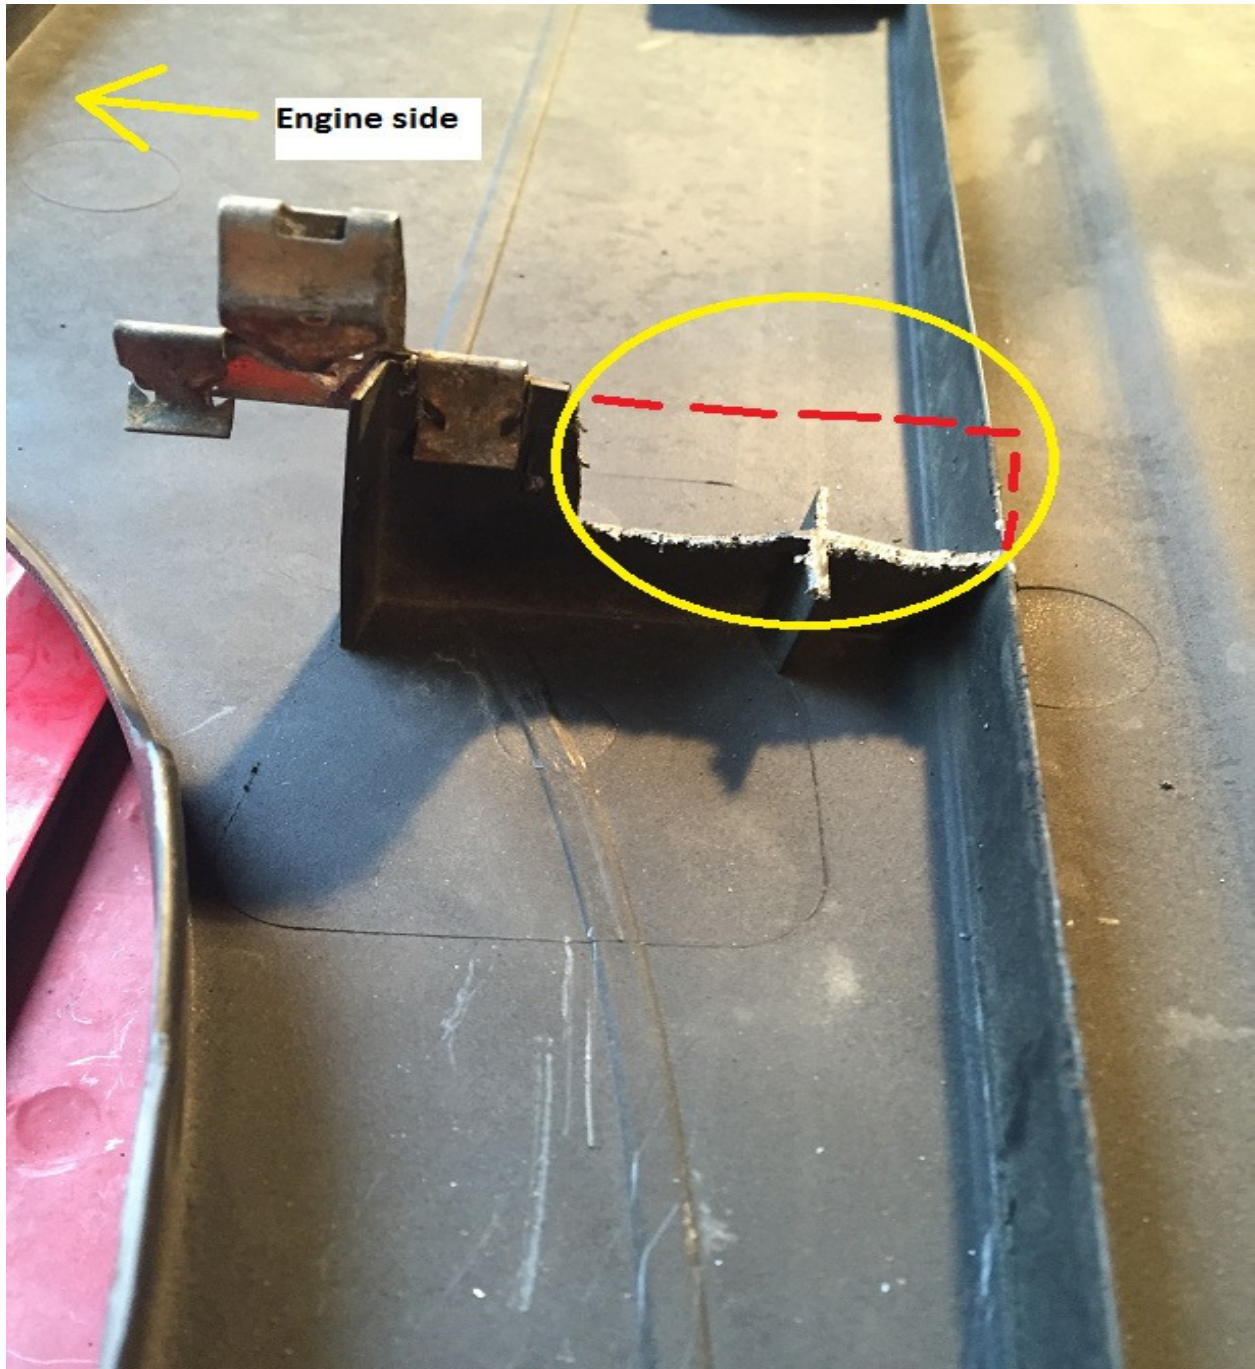
This clip is very sturdy and has teeth that bite very hard into the plastic (PIA to remove!). Because of this the mounting tab can be trimmed and the clip can be relocated with only one of the “jaws” engaged on the remainder of the mounting tab closer to the engine:

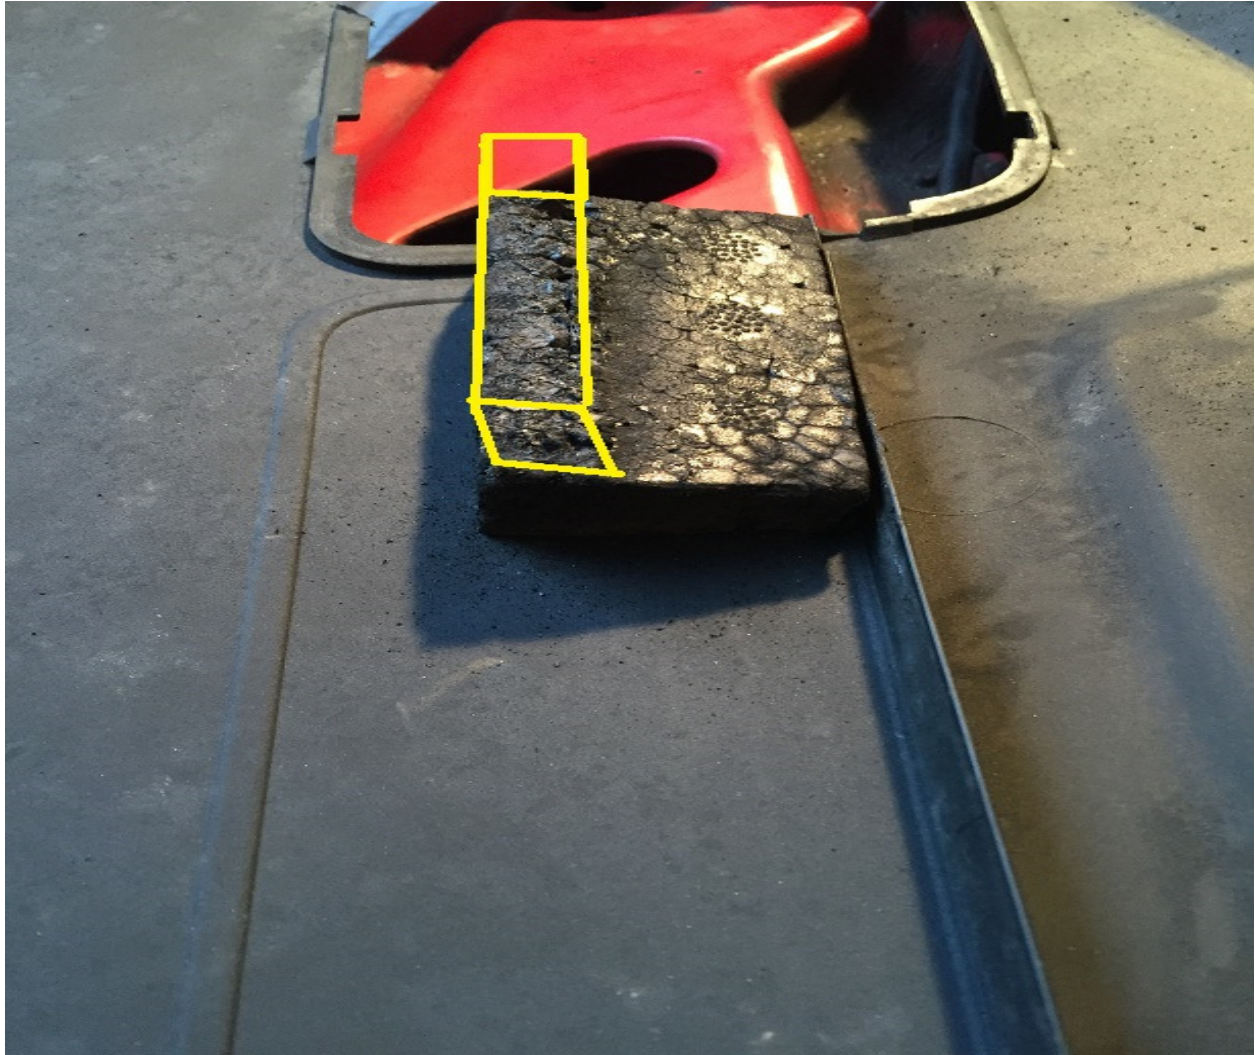
There is also a Styrofoam block that is sort of an “L” shape. This rests on top of the radiator (sorry, I didn’t get a before pic – the yellow outline shows where the part of it was that I removed):
