Installation of Cold Case Aluminum Performance Radiator in 2005 GTO

Performed October 2015

By: Chris Gray

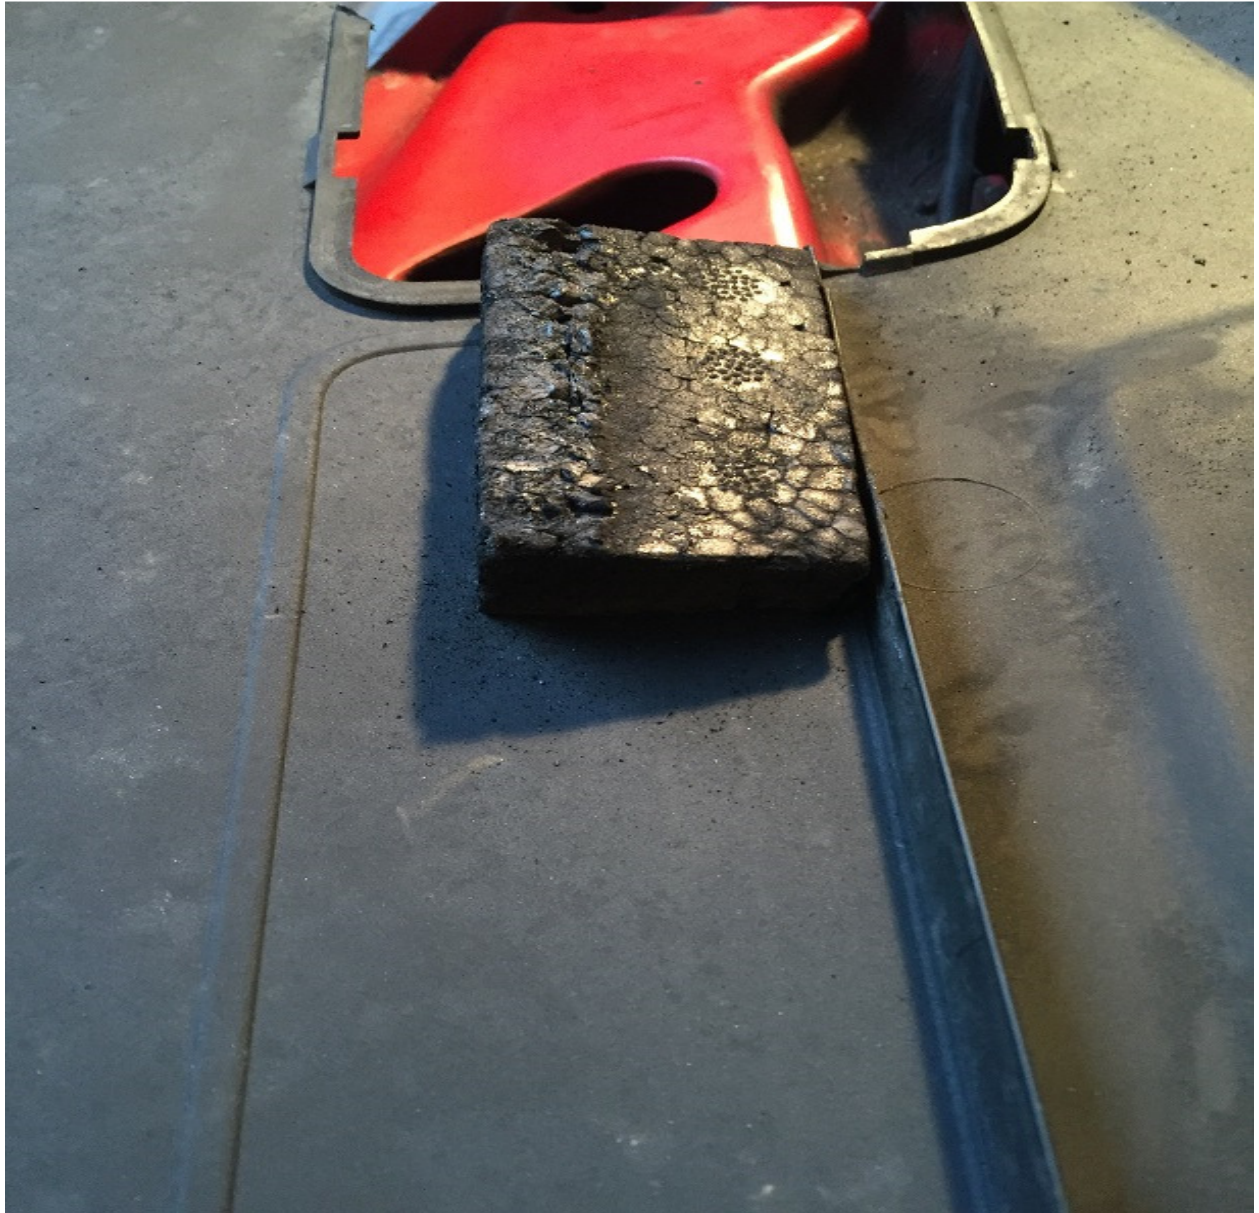
I had to trim off the top so now it is just a flat piece (same picture without my awesome sketch – lol):

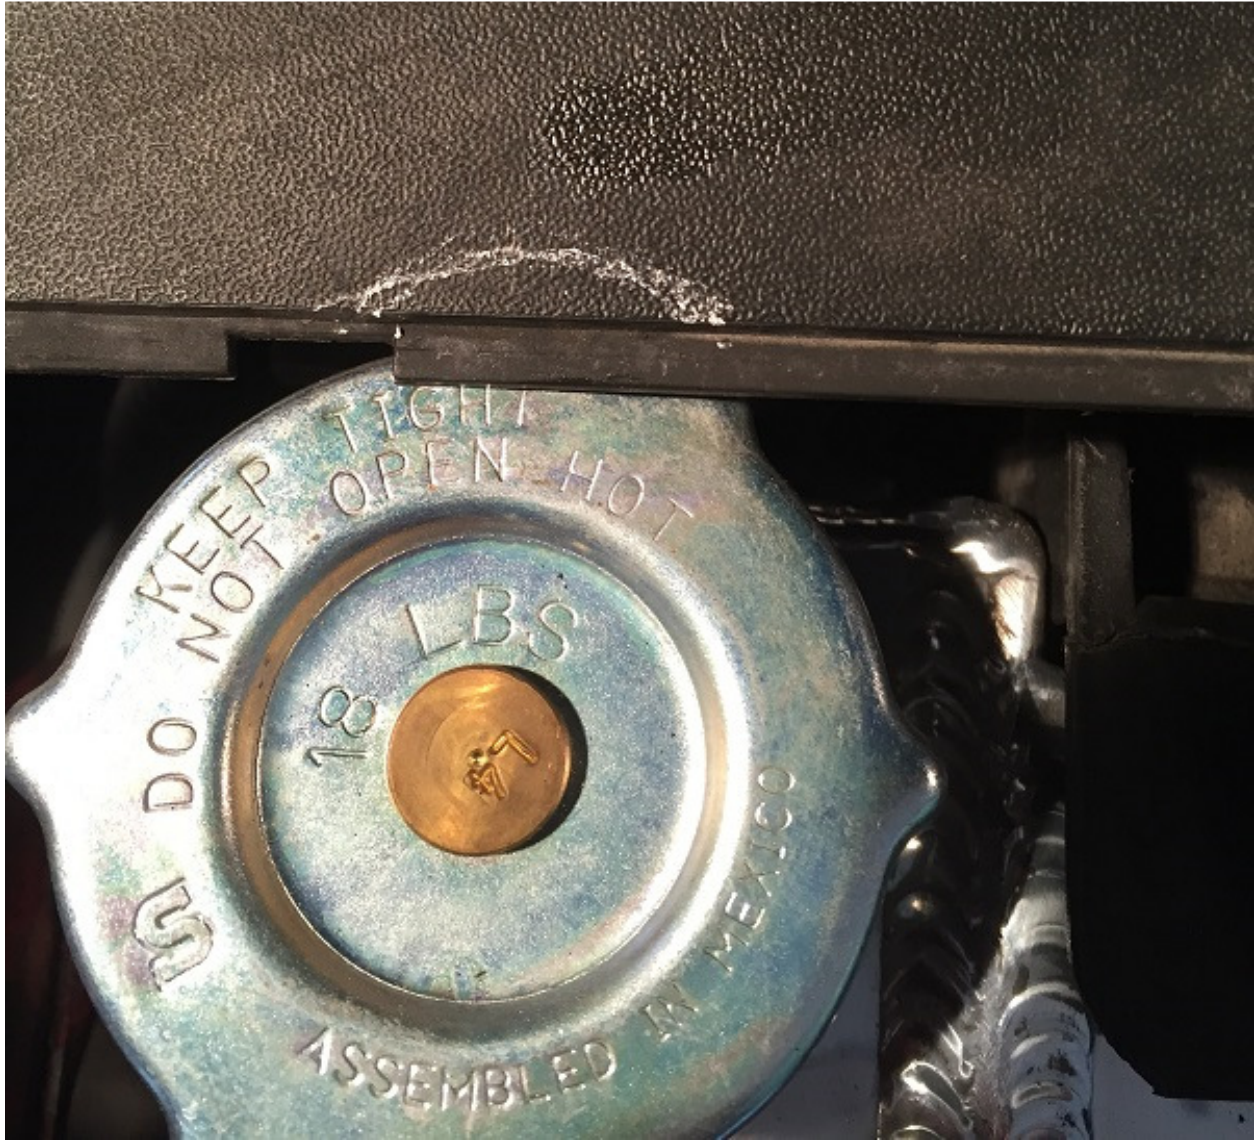
Once this was done, I realized the radiator cap was going to need more room. A small amount of plastic trimmed away and problem solved:

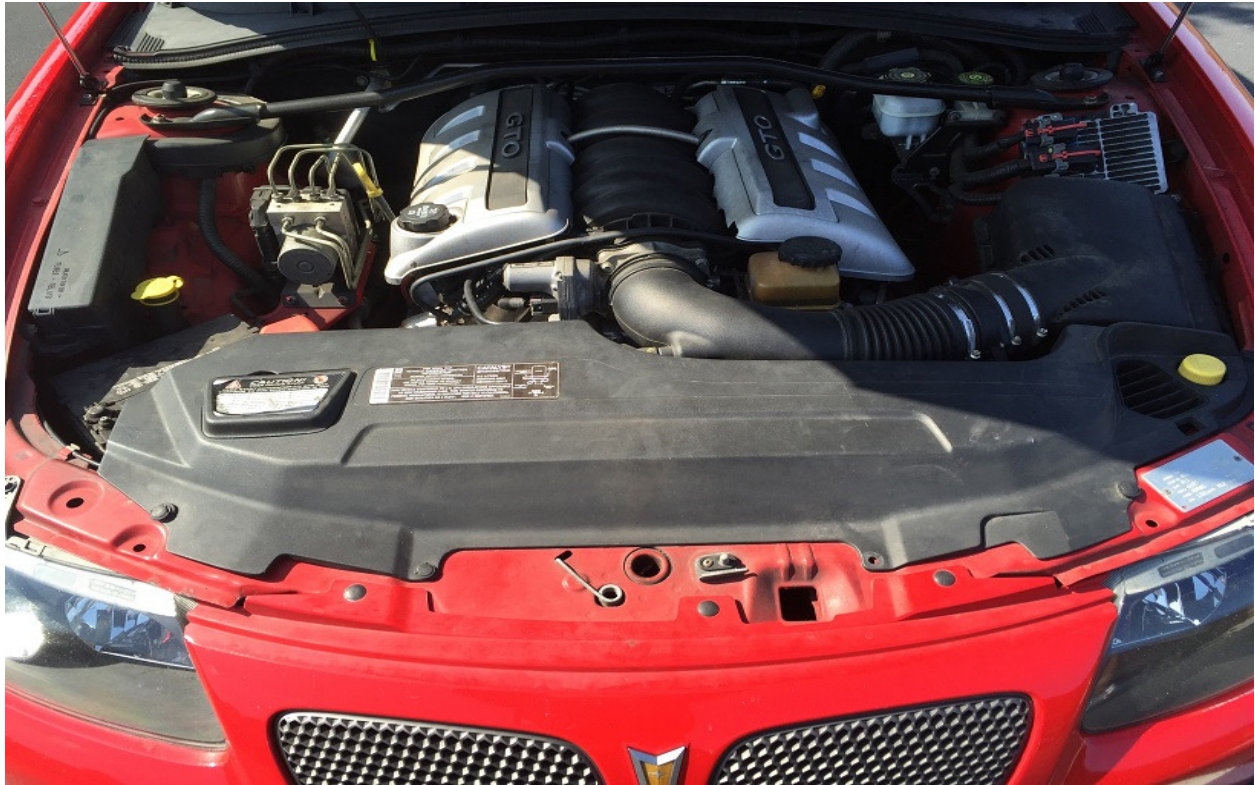
Here is the cover installed, near factory height so there is no problem closing the hood and it still retains a stock appearance:
(I know, I am missing a retainer pin...I think my dog stole it...)

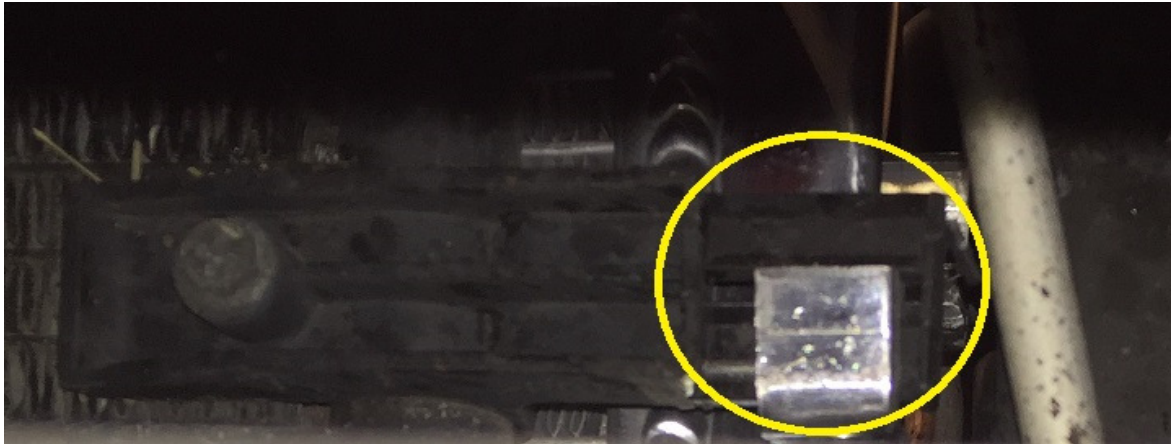
As you can see from this picture only about ½ of the tab is actually seated - this is the condenser, lower, driver side:

If I had to make one suggestion it would be regarding the AC condenser and fan assembly mounting brackets. The brackets themselves, since they don't clamp/latch on to the tabs on the condenser and fan like the factory unit, could probably be a bit bigger allowing more engagement of the tabs.

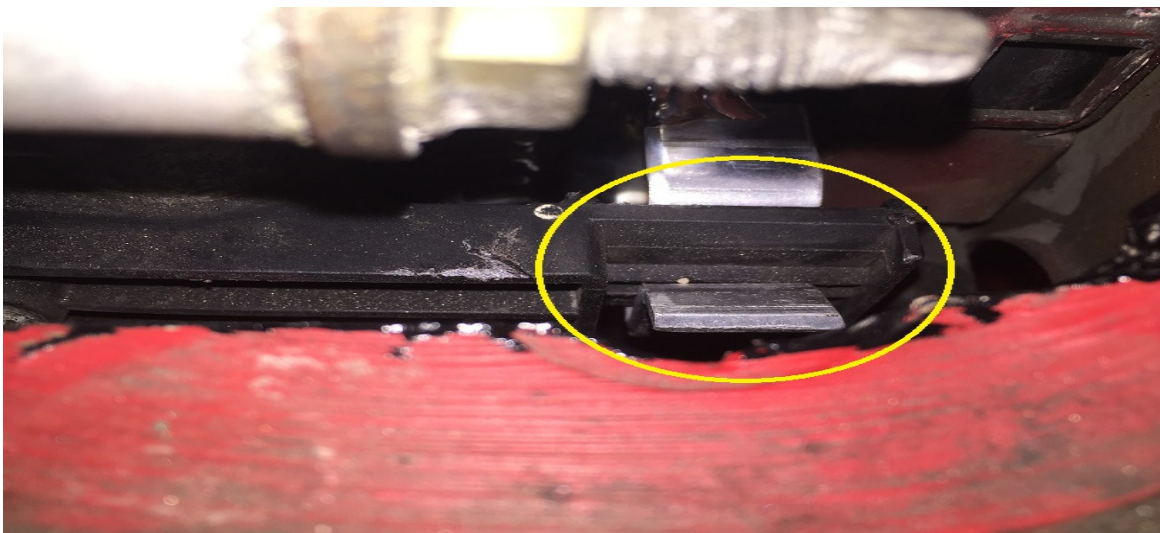
And the upper condenser bracket also only has about half of the tab seated:
